# PERFORMANCE EVALUATION OF DRAINED PAVEMENT STRUCTURES

RESEARCH PROJECT # WI 87 - 05

FINAL REPORT WI/SPR-04-98

WISCONSIN DEPARTMENT OF TRANSPORTATION  
DIVISION OF TRANSPORTATION INFRASTRUCTURE DEVELOPMENT  
BUREAU OF HIGHWAY CONSTRUCTION  
TECHNOLOGY ADVANCEMENT UNIT  
3502 KINSMAN BLVD., MADISON, WI 53704

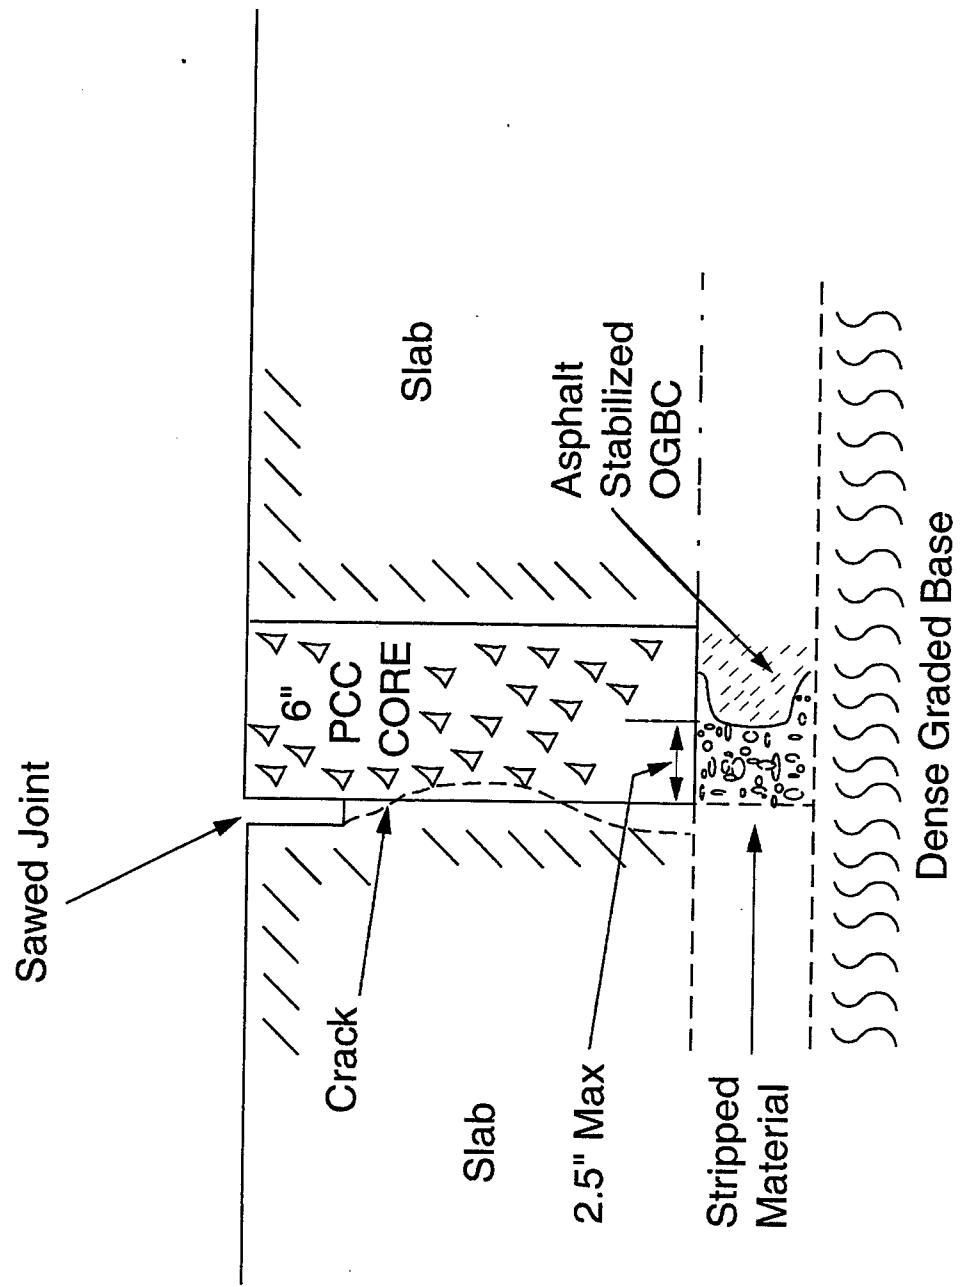
FIGURE 2.

1. Drainage Study Project Locations .....	22
2. Core Section Distress .....	23

Cores were taken from the primary projects on selected locations of test and control sections. These cores were centered on the transverse joint. No distress was seen on the surface of the coring sites prior to the coring. No deterioration was seen on the concrete portion of the cores or core holes. No deterioration was seen at the interface of the open-graded base layer and the concrete slab in non-stabilized open-graded base course, cement stabilized open-graded base course or dense-graded base course test sections. However, in the asphalt stabilized open-graded base course test sections, the asphalt-stabilized portions of the cores did show minimal stripping (Figure 2). This stripping occurred both at the top and bottom of the 10.16cm (four-inches) asphalt-stabilized layer up to a maximum of 63.5mm (2.5-inches) immediately adjacent to the joint. Loose asphalt-coated aggregate which was found in the core hole appeared to be coated aggregate on which the asphalt bond had weakened. The stripping didn't appear to have caused observable surface distress in the pavement area next to the core. However, the presence of stripping raises some doubts regarding the long term efficacy of asphalt stabilized open-graded base course.

4. Coring of the PCC transverse joints indicated no joint deterioration for any structural system, except for marginal stripping of the aggregate on the asphalt stabilized open-graded base course layer of test sections. The minimal asphalt cement stripping of the aggregate on the asphalt stabilized open-graded base course layer did not appear to cause surface distress or distress in the PCC slab directly above. However, the presence of stripping raises a concern about the long term efficacy of asphalt stabilized open-graded base course.
